# CITY OF LEWISBURG ADA SELF-EVALUATION & TRANSITION PLAN NOVEMBER 10, 2019

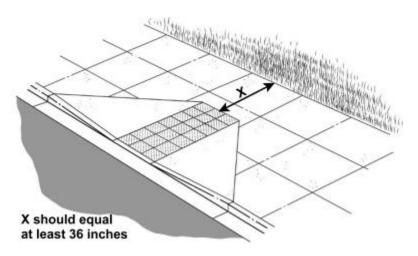
Figure 6: Landing (Source: ADA Accessibility Survey Instructions Manual)

Landings are defined as the relatively flat areas provided at the top of ramp runs. At the top of curb ramps, ADA requires landings to have a minimum clear length of 36-inches (Ref 2010 ADA Standards 406.4).

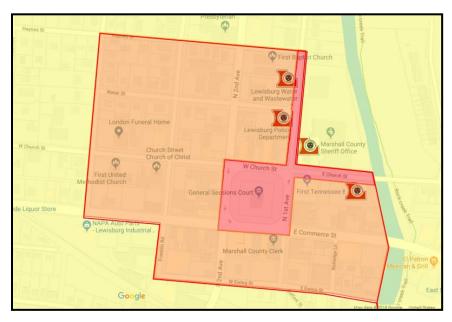
Figure 8: Priority Zones in vicinity of Public Square

A more effective visualization of these areas can be seen in Figures 8 below and the map located in Appendix E:

To assist in the project prioritization process, each zone was assigned a pre-determined value known as the "Criticality Score." A breakdown of the values assigned to each zone is shown in Table 14 below:
